OptimFlush

SATOFSHFS2

Floor-standing Rimless Toilet

INSTALLATION INSTRUCTIONS

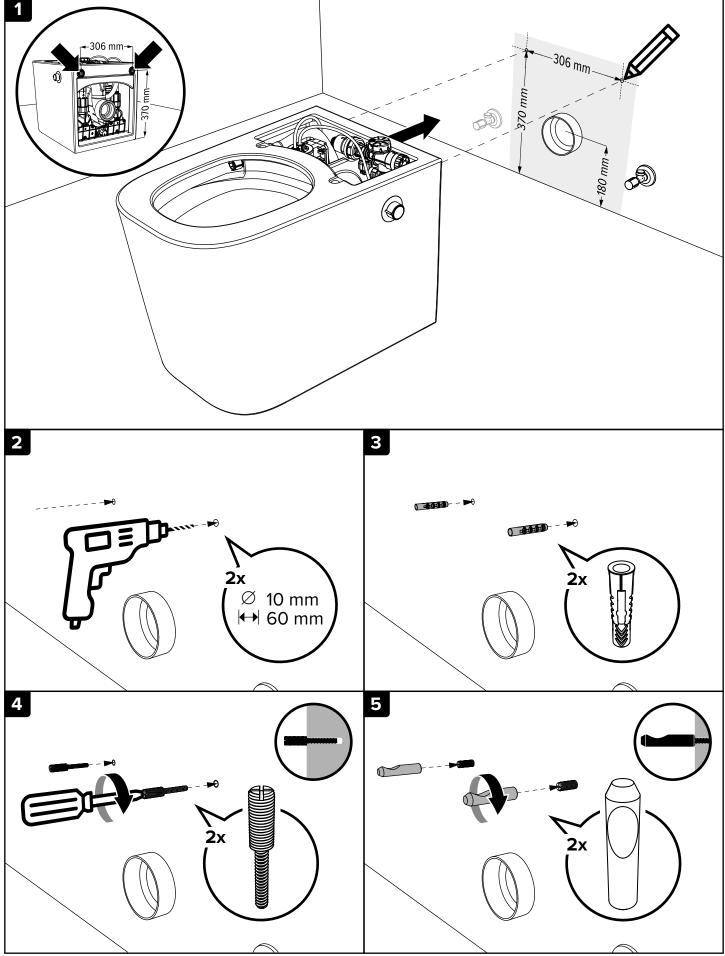
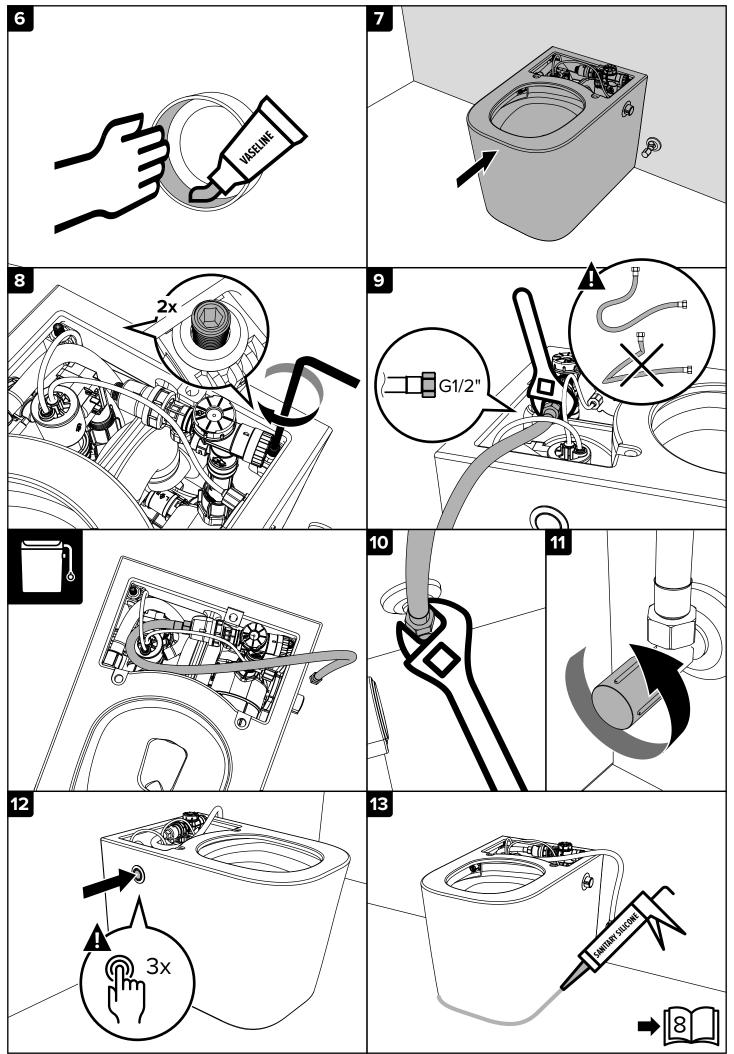
TOILET INSTALLATION

NOTE: Mounting surface must be clean and level before toilet is installed!

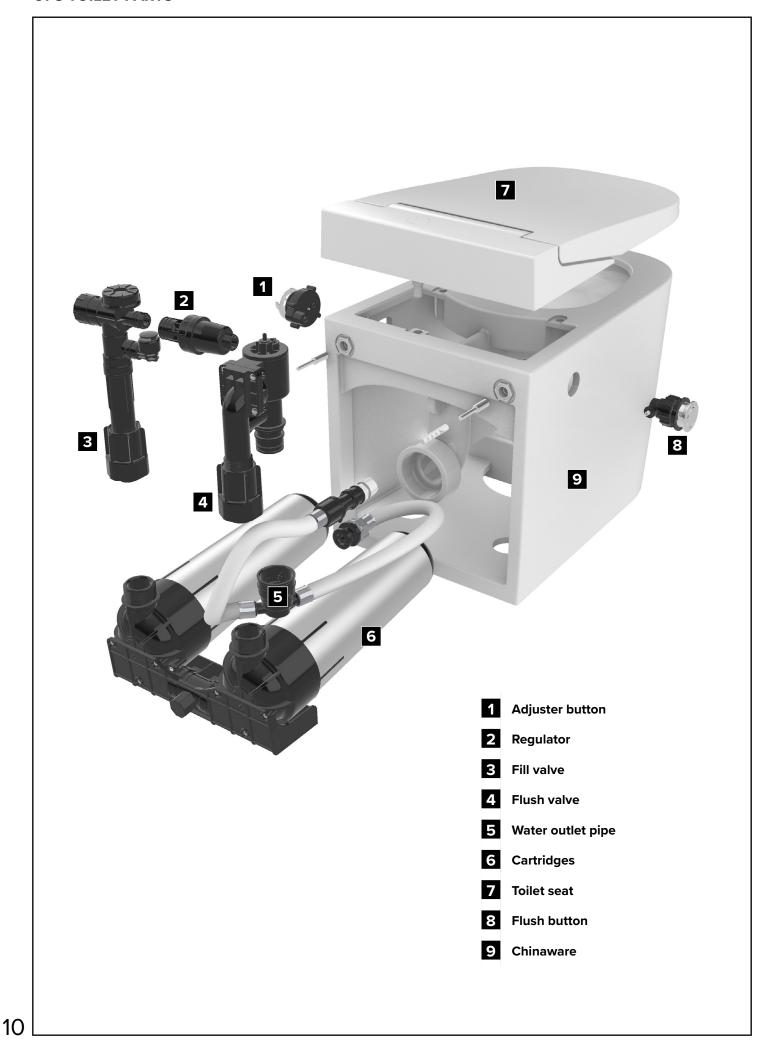
OFS TOILET PARTS

No	Part Name	Part Number	Usage
1	Adjuster button	NDSATOFSHFS2AB	1
2	Regulator	999910060150	1
3	Fill valve	112070031020	1
4	Flush valve deck & core	112070031023 NDSATOFSHFS2FV	1
5	Water outlet pipe	NDSATOFSHFS2OP	1
6	Cartridges	NDSATOFSHFS2CA	1
7	Toilet seat	NDSATOFSHFS2SE	1
8	Hydraulic flush button	112070031021	1
9	Chinaware - ceramic toilet	NDSATOFSHFS2WC	1

Problem	Possible Cause	Corrective Action
1	Toilet flushing fail	Toilet angle valve not open.	Open the angle valve completely.
		The button fail to work.	Replace button.
		The Regulator filter blocked.	Disassembly the regulator to clean filter and keep press the button 4 minutes to refill air into cartridges.
2	Toilet flushing is weak or water seal is abnormal	Water pressure too low.	Working pressure not less than 20 PSI.
		The Regulator filter blocked.	Disassembly the regulator to clean filter and keep press the button 4 minutes to refill air into cartridges.
		Dirty water causes the fill valve core blocked and limited flow rate.	Replace fill valve.
3	Toilet leaking	Dirty water causes the flush valve core seal damage and not close as normal.	Replace flush valve core.
		Dirty water causes hydraulic button fail to close.	Replace hydraulic button.
4	Toilet leakage	Dirty water cause regulator damage and leaking.	Replace regulator.

Dirty water causes fill valve damage and leaking.	Replace fill valve.
		The water supply hose not lock well.	Lock water supply hose tight enough.
		Hose washer damaged or lost.	Replace washer.
5	Toilet seat fail in slow down	The damper fail.	Replace seat.
